# Geotechnical Investigation

Greenview Industrial Gateway

Highway 40, Municipal District of Greenview, AB

Reference no. 02208360.000 (5946-001-00)

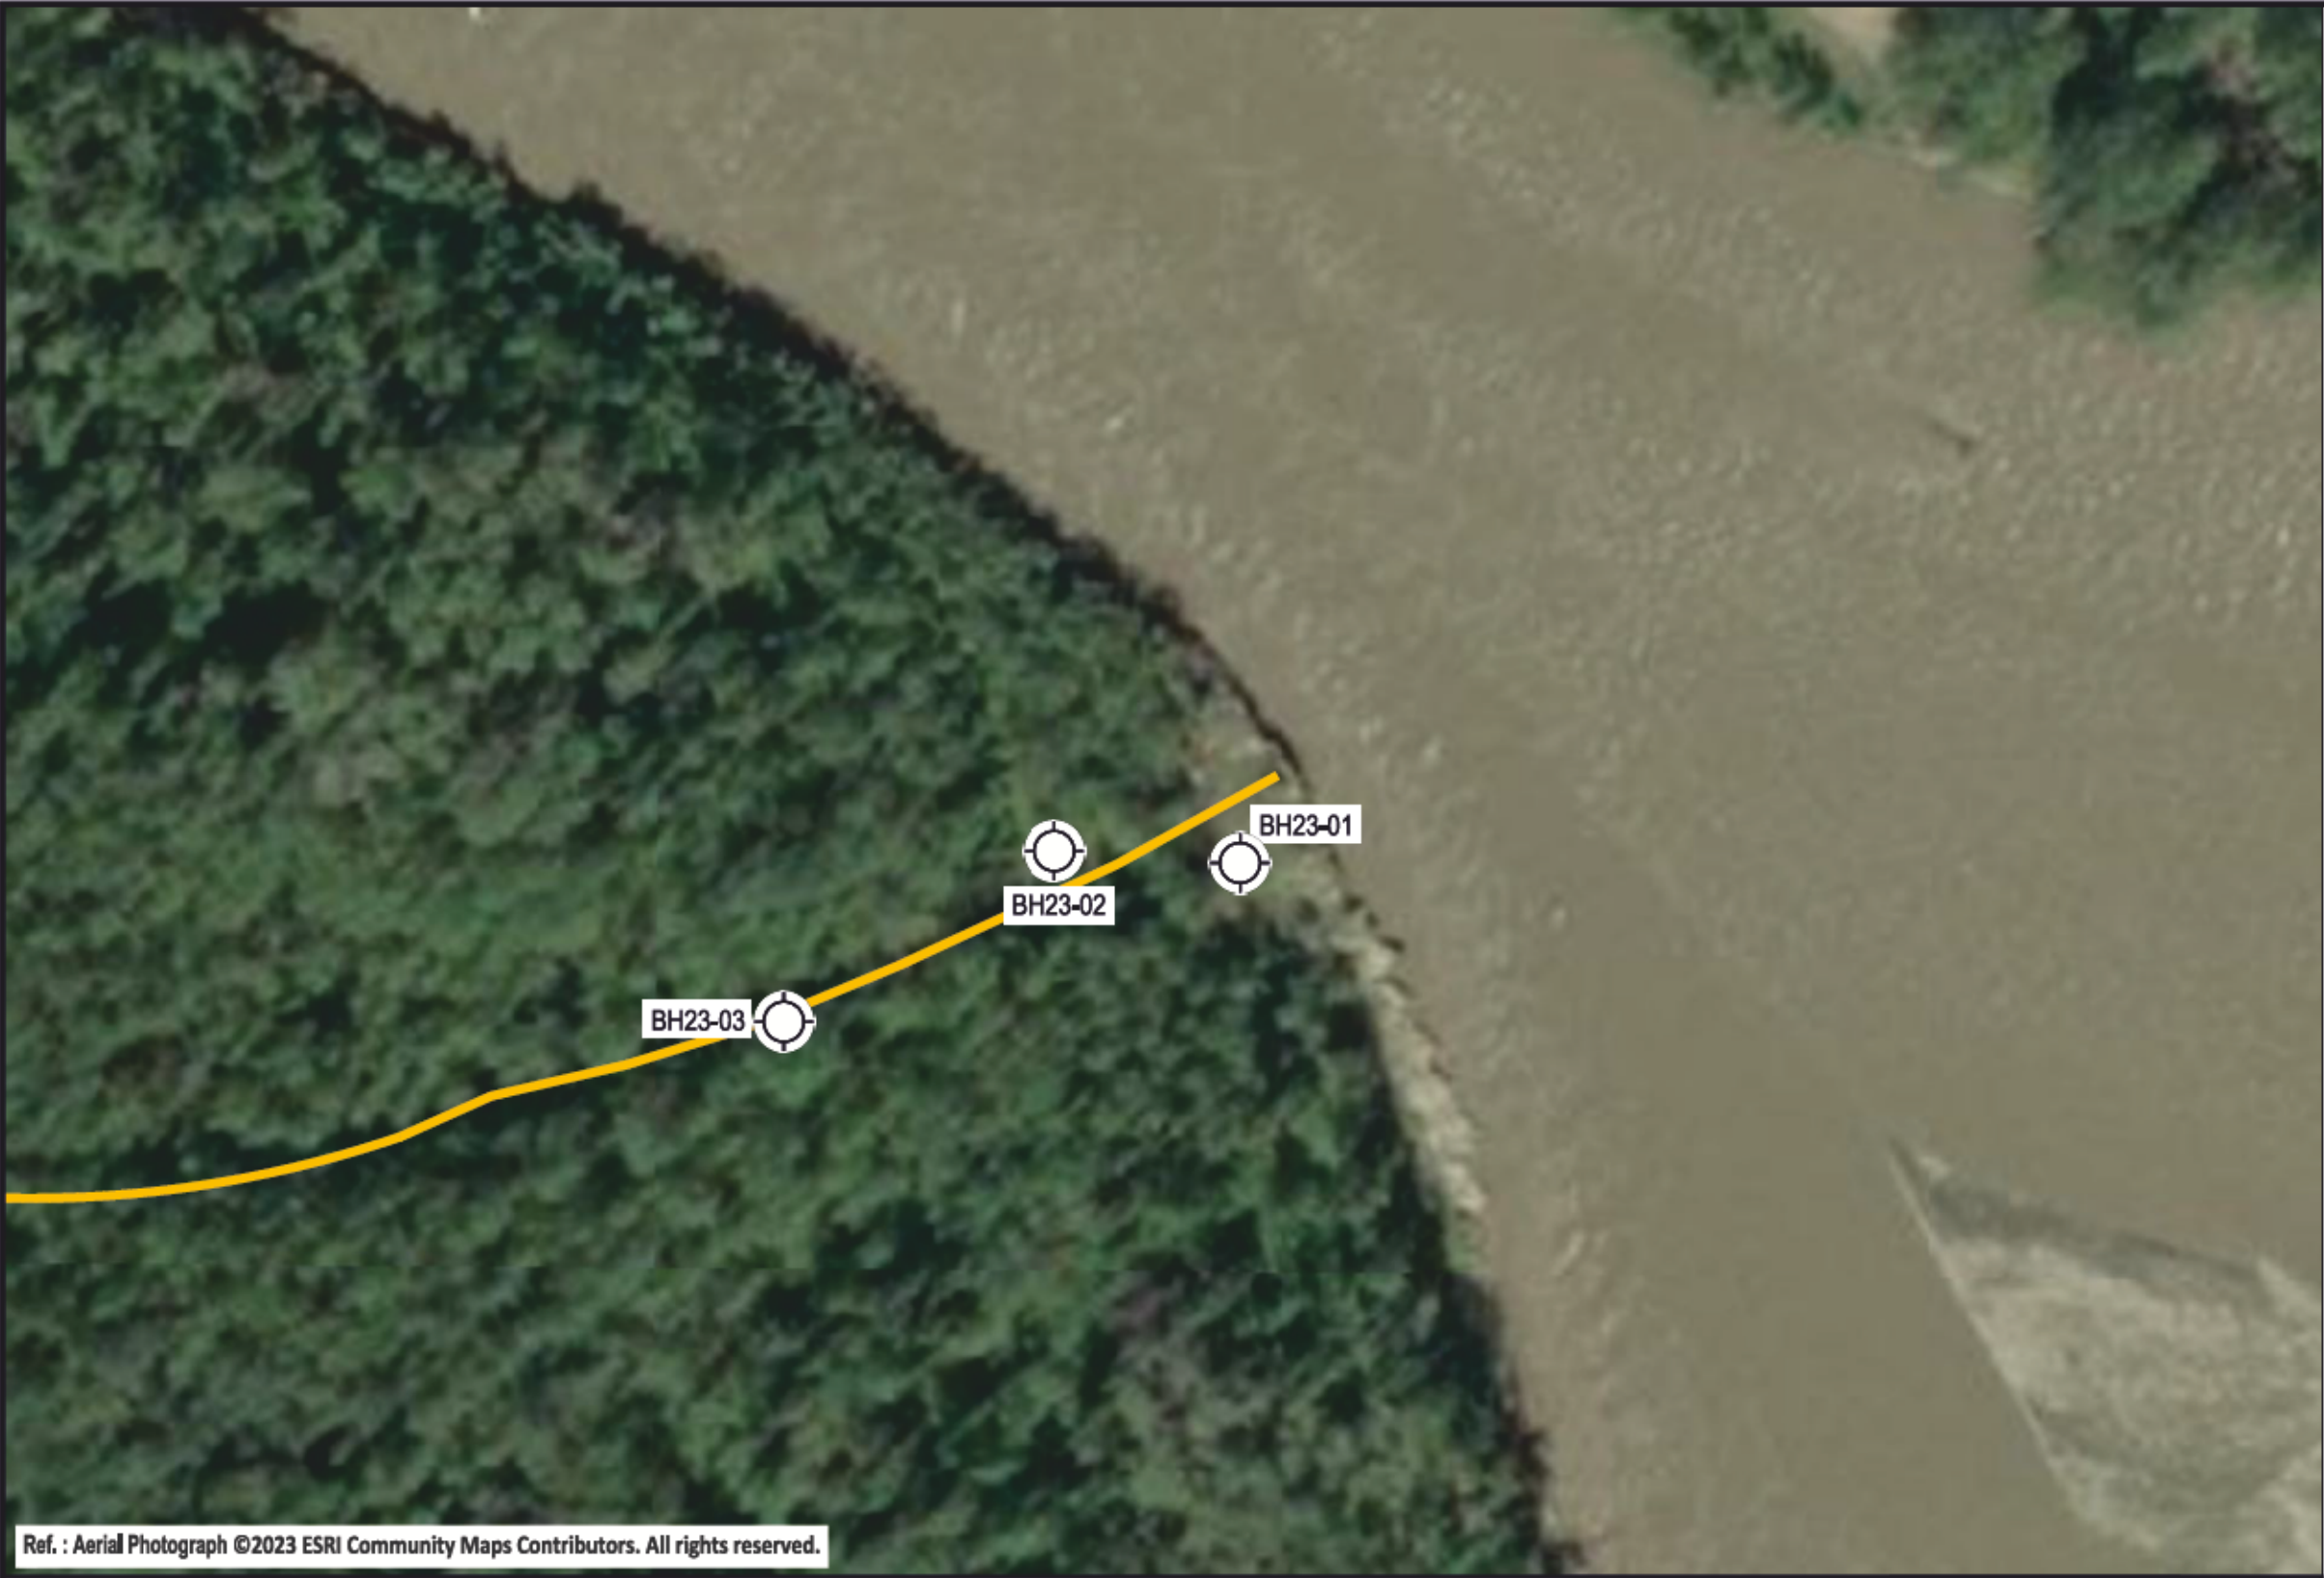
Aerial Photograph showing  
Borehole Locations and Access Routes

The borehole locations are indicated on the Site Plan (Figure 2), which is included in Appendix A. The general soil conditions are outlined briefly below.
